Nonene Spill at Loading Rack

Causal Learning Investigation

FINAL REVISION: January 16, 2012

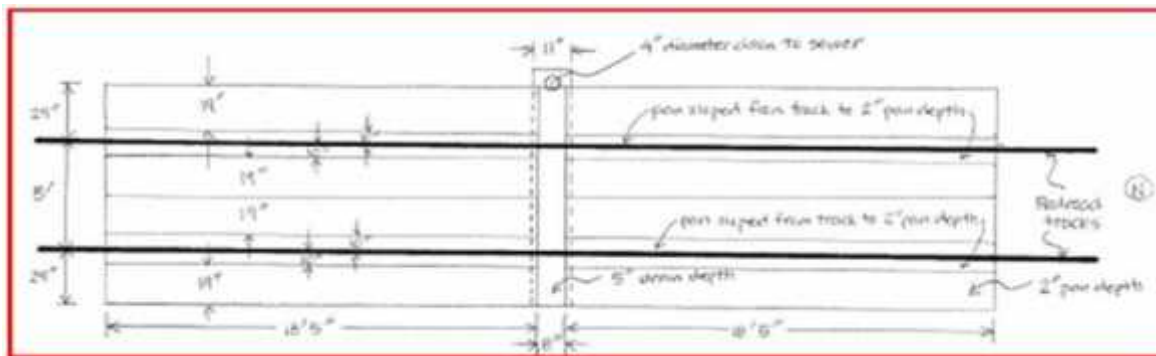
Figure 1: Shell PSR Nonene loading rack containment pan dimensions

Draining liquid material from a railcar involves opening the belly valve on the bottom of the car and allowing it to flow from the car into the containment pan below. The sloping of the containment pan is such that all liquid drains toward an 8 inch wide channel where it is then conveyed to a drain hub with a P-Trap routed to the Oily Water Sewer. Dimensions and characteristics of the containment pan including direction of flow are shown in Figure 1.

Drip pan capacity*: 183.9 gal

Trench drain capacity: 29.1 gal

Total capacity: 213 gal

- The height of the liquid in the trench was one inch below the top of the lip; area of containment where nonene slipped by was only 3 inches wide.
-
- AND
- Main containment pan was free of liquid
- AND
- 1.3.4 Drain pan was emptying toward OWS drain hub as expected
 - Hub was lowest spot in the containment pan
 - AND
 - Containment wall where nonene leaked was within inches of the drain hub
- AND
- 1.3.5 Containment wall where nonene leaked was obscured from operator and STL view
 - Operator and STL worked from other side of rail car
 - OR
 - It was dark outside
 - OR
 - Containment wall was obscured by rocks and grating
 - OR
 - Area of containment where nonene slipped by was only 3 inches wide
 - OR
 - Drainage provided by surrounding rock prevented leak detection

- 1.4.1 Drain hub was plugged or partially plugged.
 - Rocks and dirt from surrounding area were caught in P-Trap
 - P-Traps cleaned reactively
 - PSR assumes that plugged drains will be detected when there is a problems
- AND
- 1.4.2 Nonene volume exceeded containment volume of 29 gal
 - Designers assumed drain would be free flowing
 - OR
 - Designers assumed volumes of hydrocarbon drained would be less than 29 gal
- AND
- 1.4.3 Containment wall near drain hub provided path of least resistance.

What cause should be addressed?	<ul style="list-style-type: none"> Nonene slipped over a 3 inch section of containment. Drain hub was plugged or partially plugged. Containment wall near drain hub provided path of least resistance
Why? What would be the benefit?	<p>We recognize that there are scenarios which require the containment system to work (e.g., drips or sprays from bad order railcar valves). Therefore, if nonene is drained to the containment pan, it must be effectively conveyed to the OWS via the containment pan and trench as well as the p-trap underground.</p>
How? What would be the solution?	<ol style="list-style-type: none"> 1. Improve design of nonene containment pan to ensure that the lowest containment wall location overflows to a highly visible area such as the main drip pan itself. 2. Develop best practice for verifying integrity of the OWS containment system under the nonene loading rack.

How the solution would prevent similar incidents in the future	Operator will be able to identify a malfunctioning OWS containment system before nonene or other product leaks to the environment.
Action Plan:	<p>Who: Bill Mercer What: Modify the design of north and south nonene containment pans around the pipe going to OWS, such that it will reveal overflow and/or a clogged drain in visible area before it overflows to the ballast rock. Issue design package (make sure it references FIM item for completion). When: 2/12/2013</p> <p>Who: Renee Porter What: Ensure that containment pan engineering package is installed in the field. When: 9/23/2014</p> <p>Who: Brian Deaton What: Implement practical solution for verifying integrity of OWS containment system before choosing to drain a railcar. (e.g. complete inspection of containment walls and ensure the drain is free flowing) When: 9/3/2012</p>
